**UNITED STATES ENVIRONMENTAL PROTECTION AGENCY
REGION 10**

NOTICE OF VIOLATION

NPDES Inspection Report

Clearwater Paper Corporation

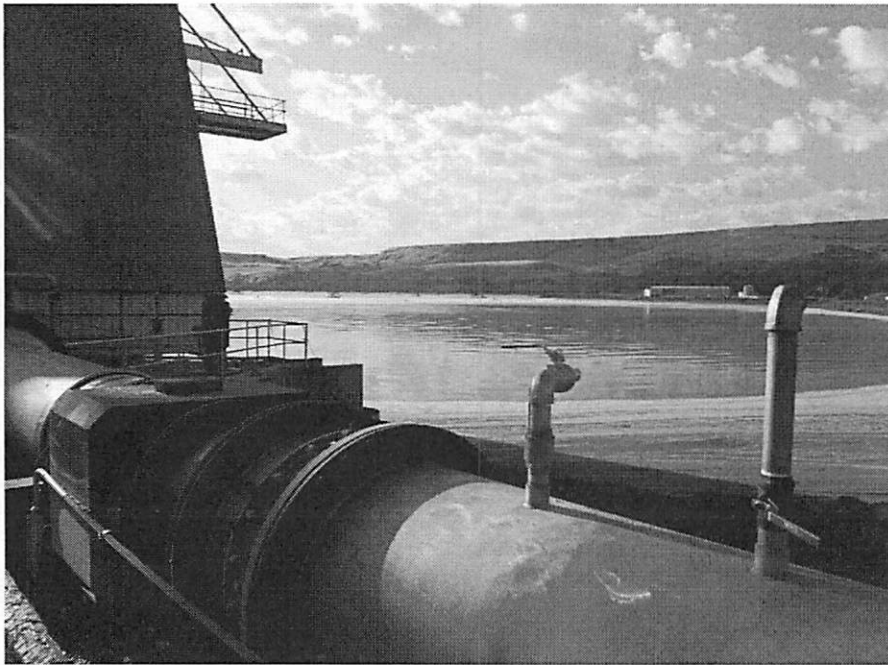
I inspected the mix basin (**Photo 1**) and ASB (**Photo 2**), which was equipped with 22 aerators. I also inspected the on-site laboratory and observed the collection of samples of mix basin influent, ASB effluent (**Photo 3**) and bleach plant effluent (**Photo 4**).

Photo 1 / P1010795 – Southeasterly view of the aerated stabilization basin

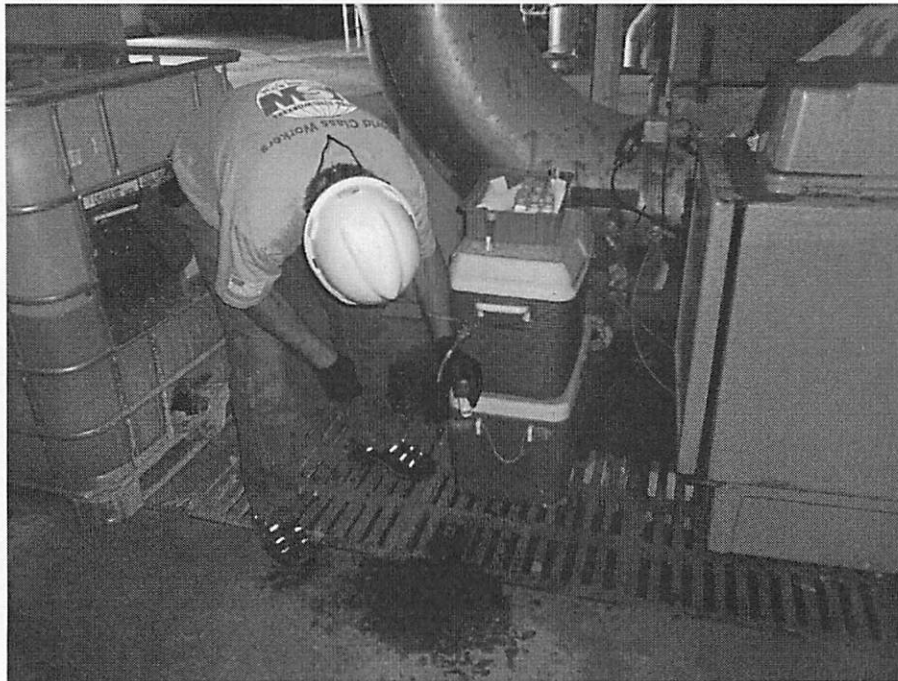
At the time of the inspection, the Facility stated that the pH was tested in the laboratory rather than at the time of collection. This could cause the sample to be analyzed outside of the 15 minute analysis window.

At the time of the inspection, the Facility said that bleach plant wastewater was collected through steel tubing. This is a violation of Part I.F.3.b.1 of the Permit.

During the inspection, Mr. Hoesman said that the facility collects bleach plant wastewater samples (**Photo 4**) through steel tubing (**Photo 5**), because steel tubing performs better than Teflon® tubing specified in the permit.

During the collection of bleach plant wastewater samples (**Photo 4**), I observed that the facility measured temperature, but not pH in the field. Mr. Hoesman said that the facility measures pH in the lab. Because each bleach plant sampling event calls for multiple sample containers and multiple sample locations, it is unlikely that the facility would be able to return to the laboratory and complete pH analysis within the 15 minute holding time specified under 40 CFR 136.

Photo 4 / P1010814 – Sample collection at sampling point 021A, which represents process wastewater from the bleach plant's acid bleaching stage

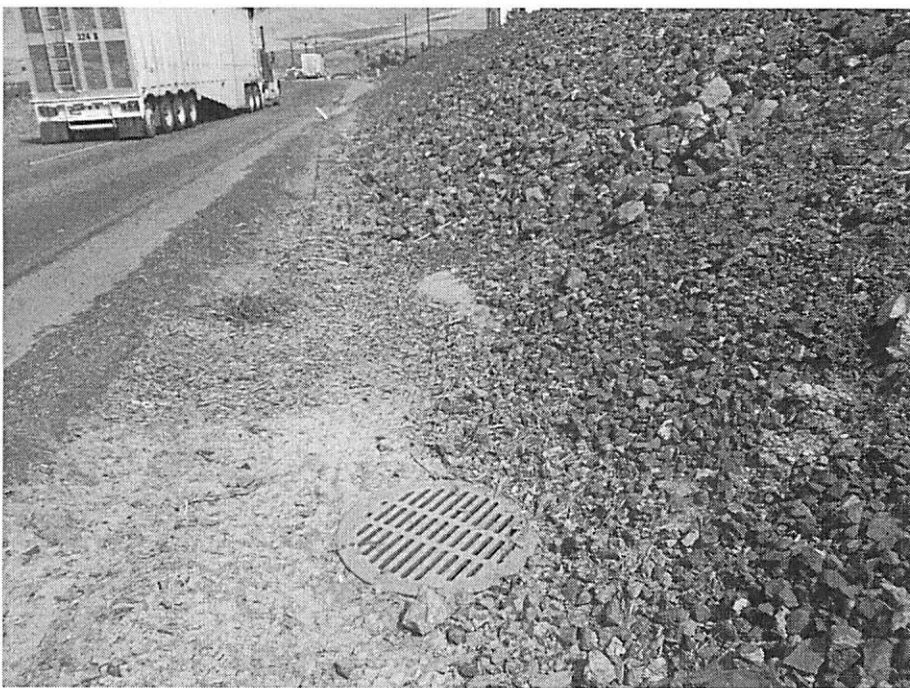
I also visited the location of the last of the stormwater outfalls to be decommissioned. According to Mr. Hoesman, stormwater outfall 007 has been replaced by a sump (**Photo 6**) located along the southwestern berm of the ASB.

Photo 6 / P1010807 – Northerly view of the sump that replaced stormwater outfall 007
